Manhole Inspection Summary

Manhole # S17A__019MH

Insp Date: **11/27/07 9:33 AM**

Location Address: **637 BENTALOU**

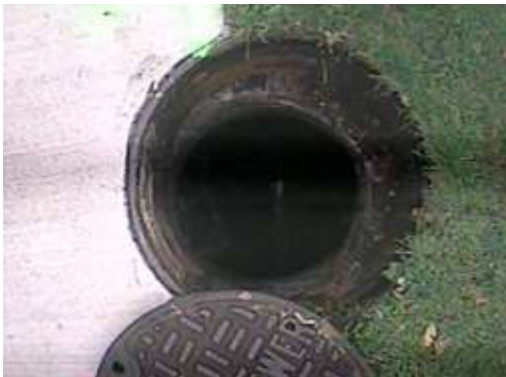
Defect 1

Offset: **4** (in.)

FRAME OFFSET

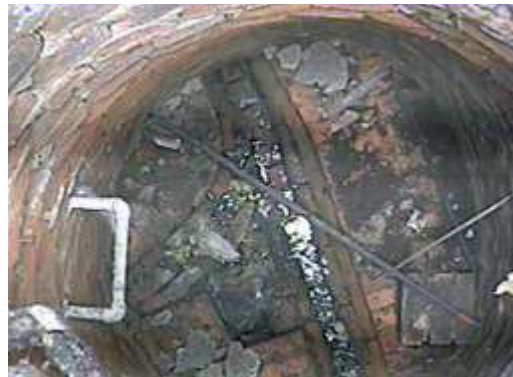
Defect 2

Condition: ☐ Sound ☒ **Cracked** ☐ Root Intrusion ☒ **Deteriorated** ☐ Leaks ☐ Debris

DEBRIS IN BENCH / BENCH
DETERIORATED

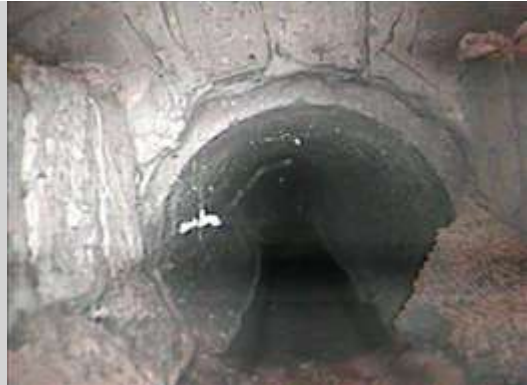
12 O'Clock Outflow

8 in. Circular Gravity Sewer
Pipe Out @ 12 O'Clock

Pipe Material: **Clay** ☐ Pipe Lined

Invert Depth: **8.08** (ft.) Flow Characteristics: **Slow**

Infiltration: **None** Pipe Seal Cond: **Sound**

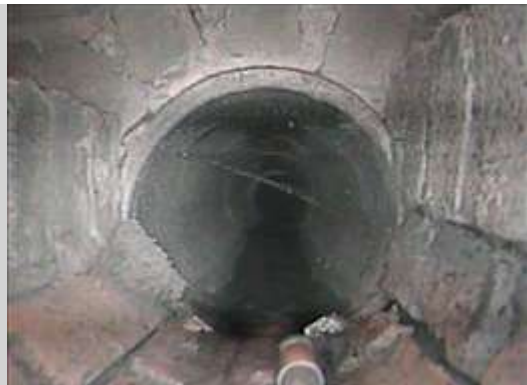
6 O'Clock Inflow

8 in. Circular Gravity Sewer
Pipe In @ 6 O'Clock

Pipe Material: **Clay** ☐ Pipe Lined

Invert Depth: **8.06** (ft.) Flow Characteristics: **Slow**

Infiltration: **None** Pipe Seal Cond: **Sound**

Connects To: **Stub connection / abandoned**

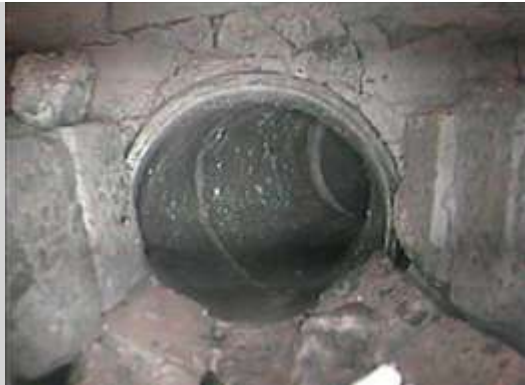
9 O'Clock Inflow

6 in. Circular Gravity Sewer

Pipe In @ 9 O'Clock

Pipe Material: **Clay** ☐ Pipe Lined

Invert Depth: **7.90** (ft.) Flow Characteristics: **None**

Connects To: **House connection / Service line**
